**DEPARTMENT OF TRANSPORTATION**

Contract #: 04-0120F4Cty: SF/ALA Rte: 80 PM: 13.2/13.9File #: 69.28**WELDING INSPECTION REPORT****Resident Engineer:**Siegenthaler, Peter**Address:** 333 Burma Road**City:** Oakland, CA 94607**Report No:** WIR-021248**Date Inspected:** 07-Nov-2010**Project Name:** SAS Superstructure**OSM Arrival Time:** 700**Prime Contractor:** American Bridge/Fluor Enterprises, a JV**OSM Departure Time:** 1900**Contractor:** Zhenhua Port Machinery Company, Ltd (ZPMC), Changxing Island **Location:** Shanghai, China**CWI Name:** Li Yan Hua**CWI Present:** Yes No**Inspected CWI report:** Yes No N/A**Rod Oven in Use:** Yes No N/A**Electrode to specification:** Yes No N/A**Weld Procedures Followed:** Yes No N/A**Qualified Welders:** Yes No N/A**Verified Joint Fit-up:** Yes No N/A**Approved Drawings:** Yes No N/A**Approved WPS:** Yes No N/A**Delayed / Cancelled:** Yes No N/A**Bridge No:** 34-0006**Component:** OBG Segment Assembly**Summary of Items Observed:**

**OBG Segment 12BE**

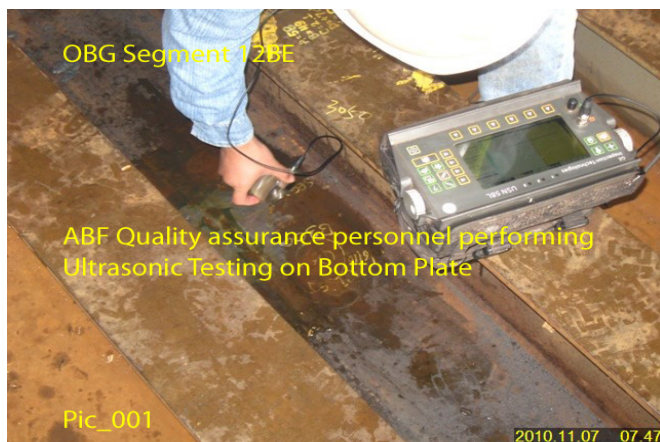
During in process inspection this QA Inspector observed ABF Quality assurance personnel performing Ultrasonic Testing (UT) on Bottom Panel longitudinal weld after repair. Weld # SEG3002A-003. See attached photograph Pic\_001.

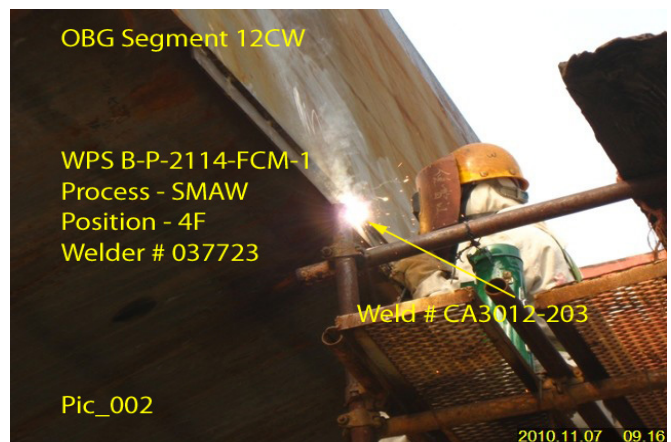
Shielded Metal Arc Welding (SMAW) in the 4F position of weld # CA3012-203 of Counterweight side Drain Plate. The welder is identified as 037723. ZPMC CWI is identified as Wu Shi Gao. The welding variables recorded by QC appeared to comply with the WPS B-P-2114-FCM-1. See attached photograph Pic\_002.
